September 25, 2014

Revised December 10, 2014

Re: Forest Conservation Act Variance request for tree removal  
3 Milkshake Lane PD-2012-001

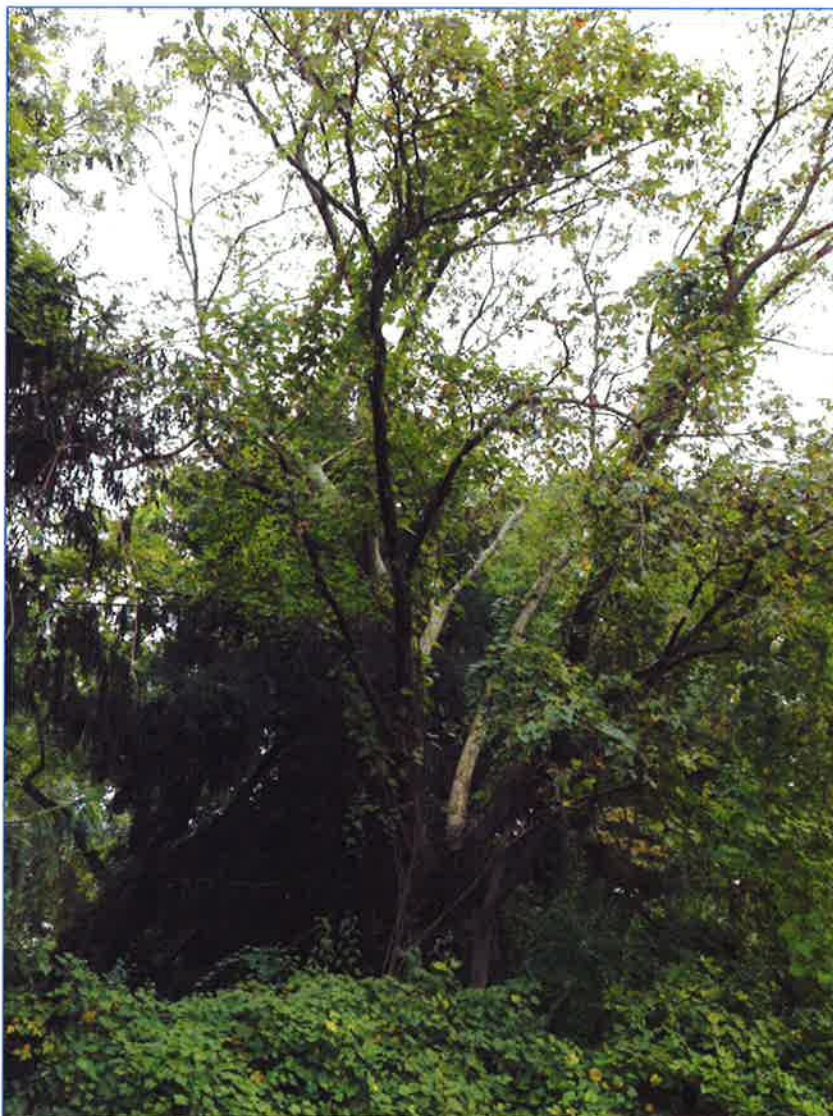
**TREE #**            **10**

22" Elm

FAIR (59%)

Exhibits some crown dieback, crown decline, thinning crown, and vines.

This tree is located within the access road which has been located in the area of the existing driveway.

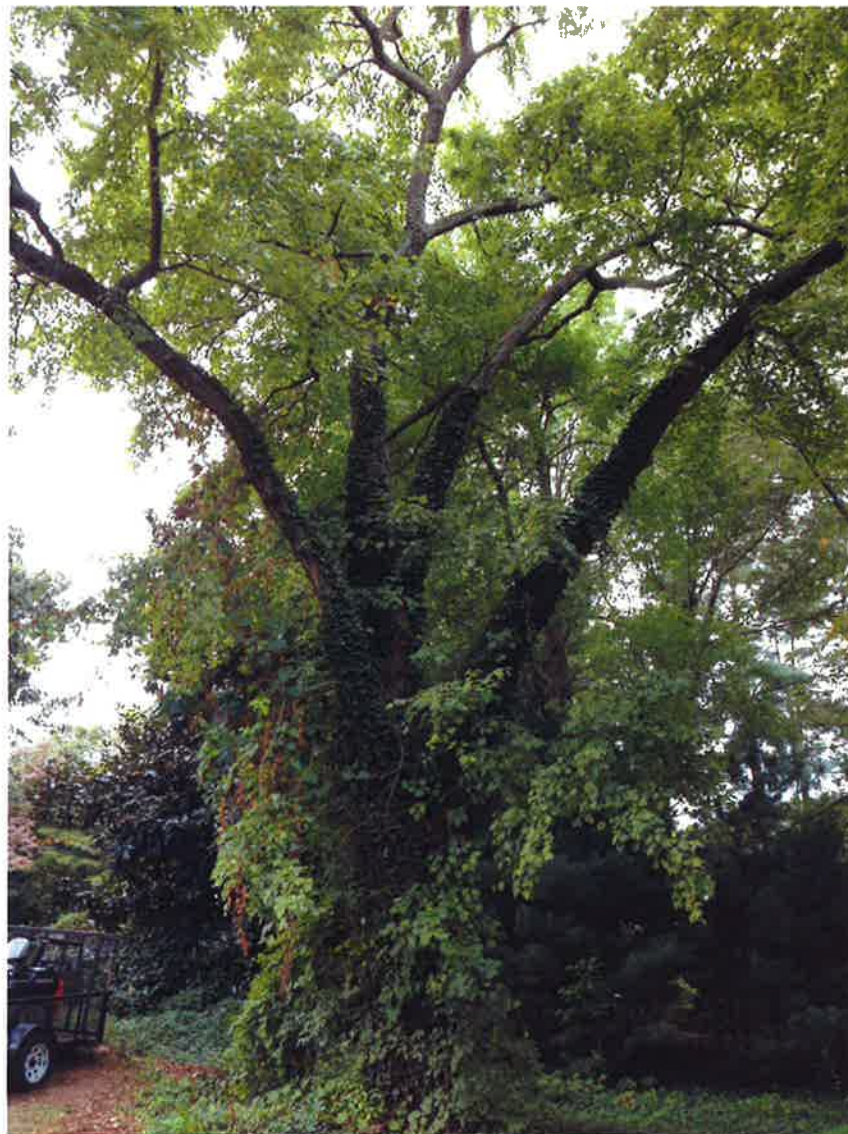
**TREE # 13**

28" Red Maple

FAIR (63%)

English ivy vine cover, broken limbs, weak union.

This tree is located within the access road which has been located in the area of the existing driveway.

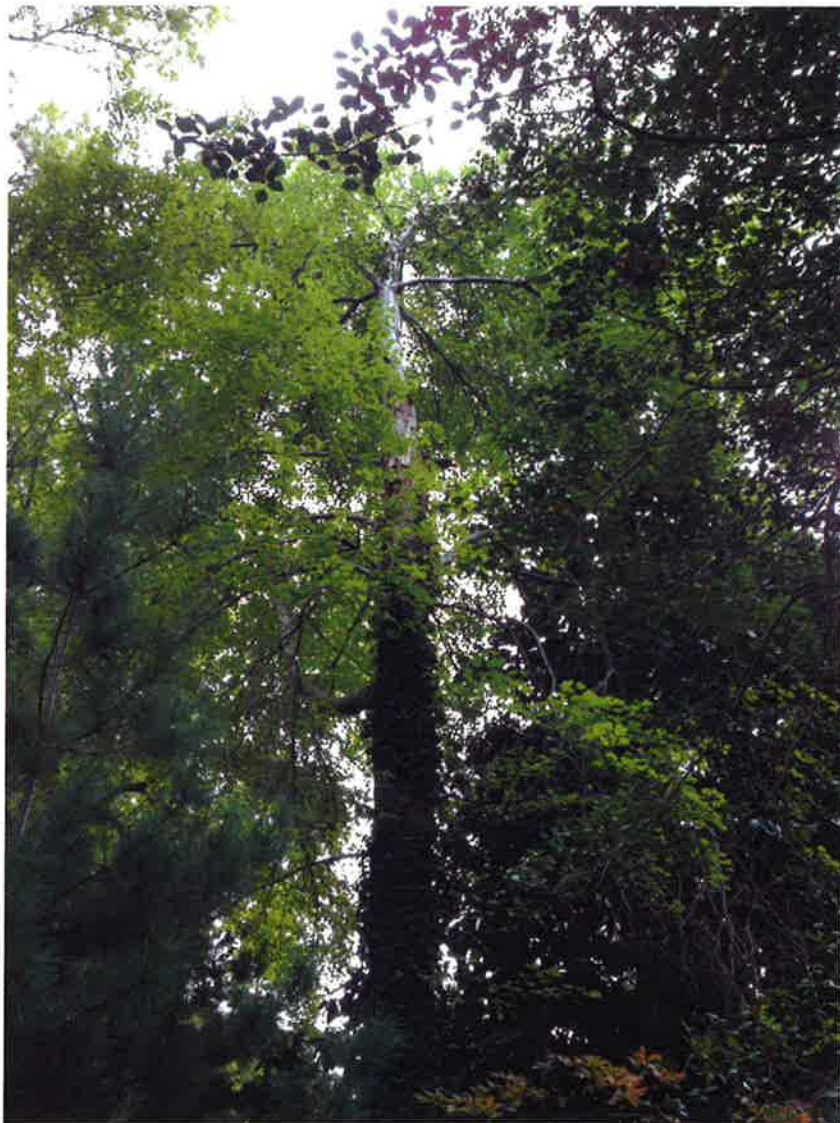
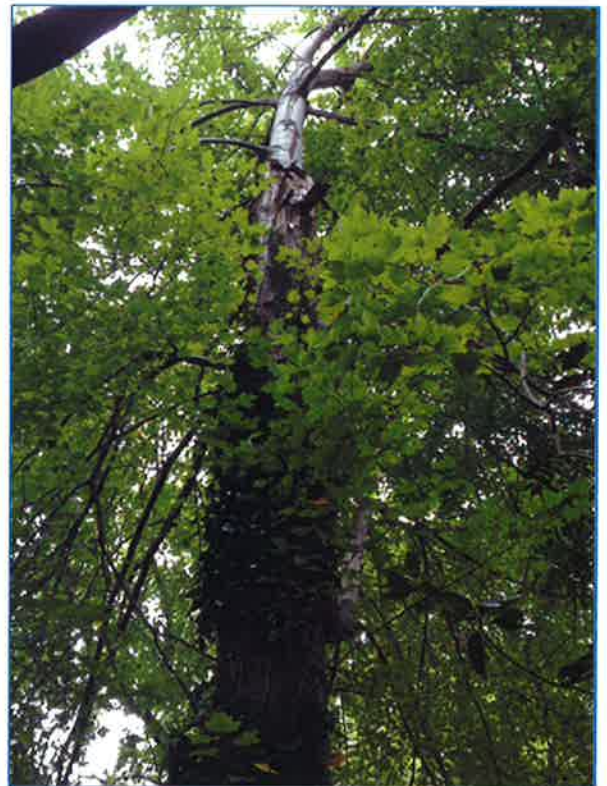
**TREE #**            **20**

21" Red Maple

POOR (41%)

Broken leaders, broken limbs, weak union and serious decline

*Broken Co-Dominant leader*

This tree is in serious decline, and is a safety hazard.

Tree #20 is outside of the proposed LOD, and could be preserved, but based upon the recommendation of our arborist, the tree is in serious decline, is a safety hazard, and must be removed. The tree will be removed by a qualified Arborist "by hand" to minimize potential impact to adjacent trees.

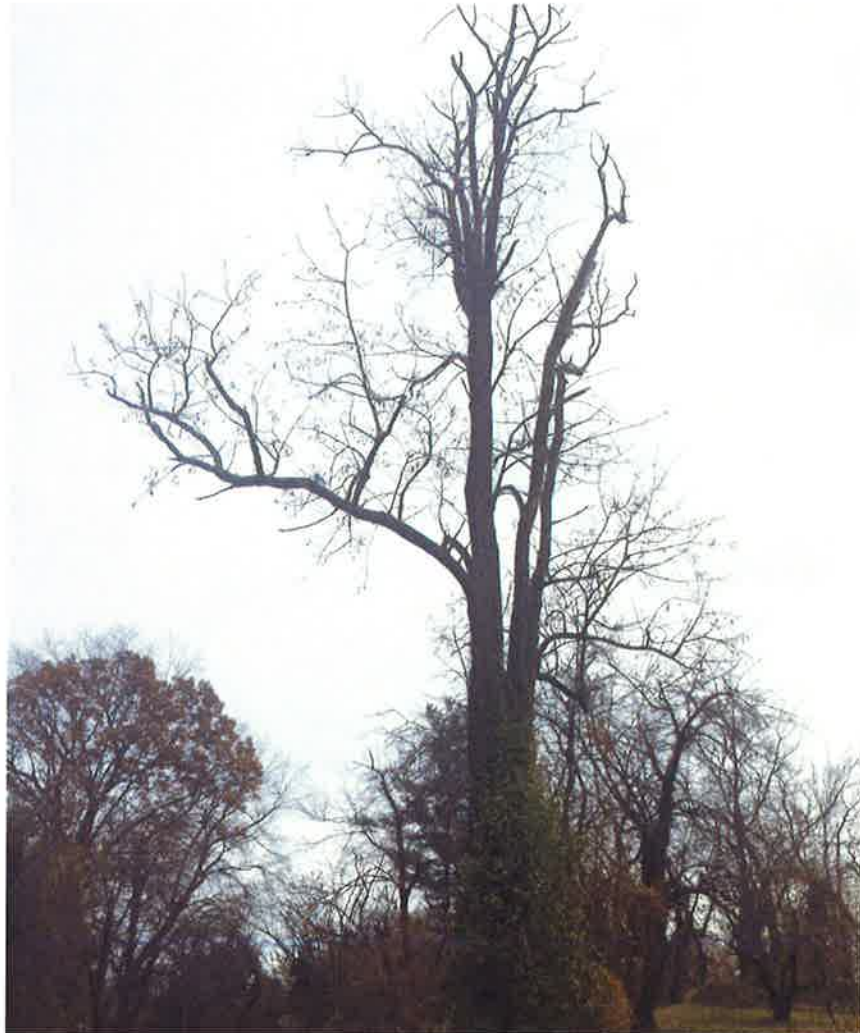
**TREE #**            **50**

30" Black Locust

POOR (44%)

Sever crown dieback, broken limbs, weak union, serious decline

Though this tree is located within the LOD, it was not a candidate for preservation as the tree is in serious decline, and is a safety hazard.

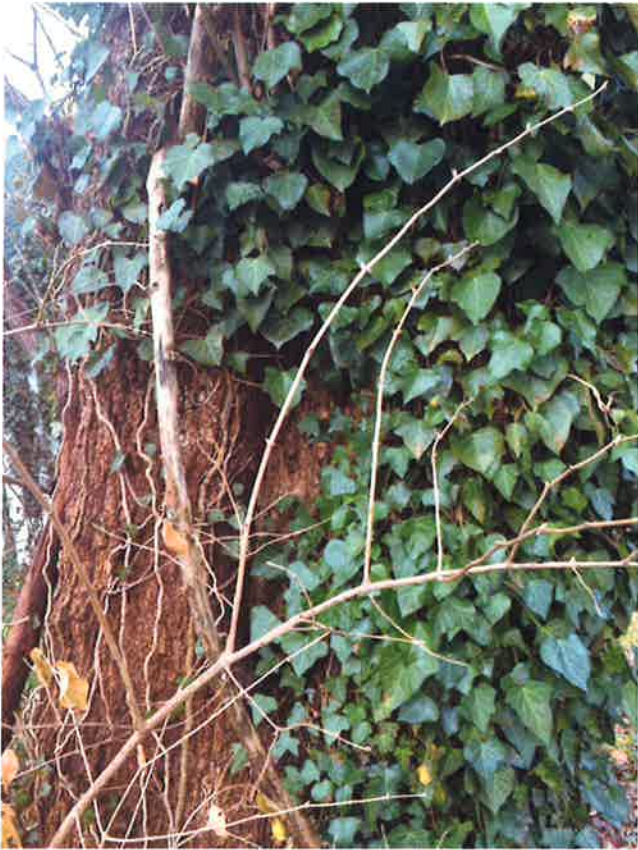
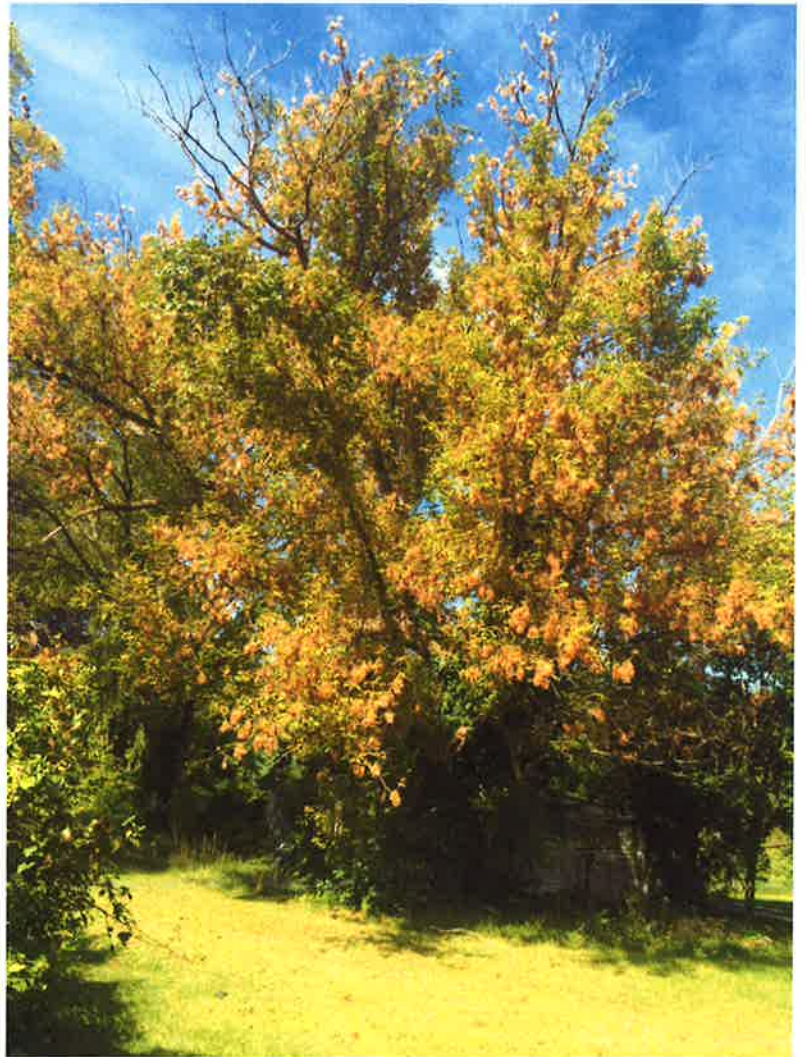
**TREE #**            **56**

46" Boxelder

FAIR (58%)

Large area of decay in the main trunk and large broken leader with significant decay and general crown decline

Though this tree is located within the LOD, it was not a prime candidate for preservation as the tree is in decline.

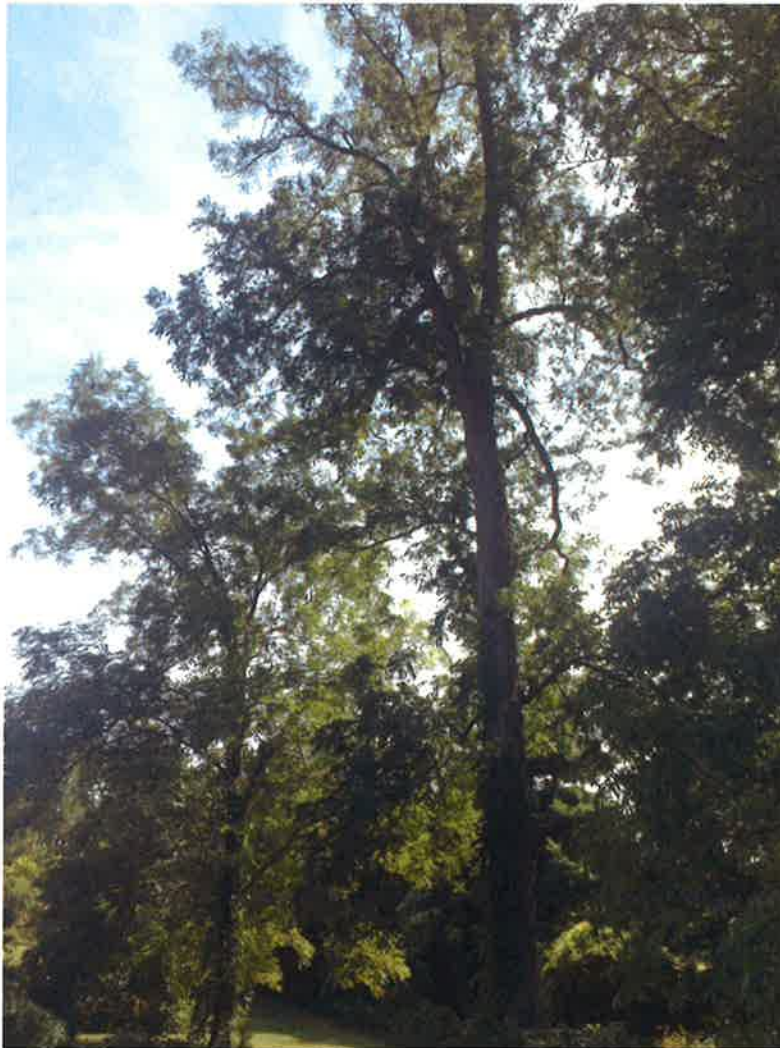
**TREE #**            **63**

34" Pecan

GOOD (70%)

Trunk decay, broken limbs and vines

This tree is located in an area within the LOD proposed for housing units.

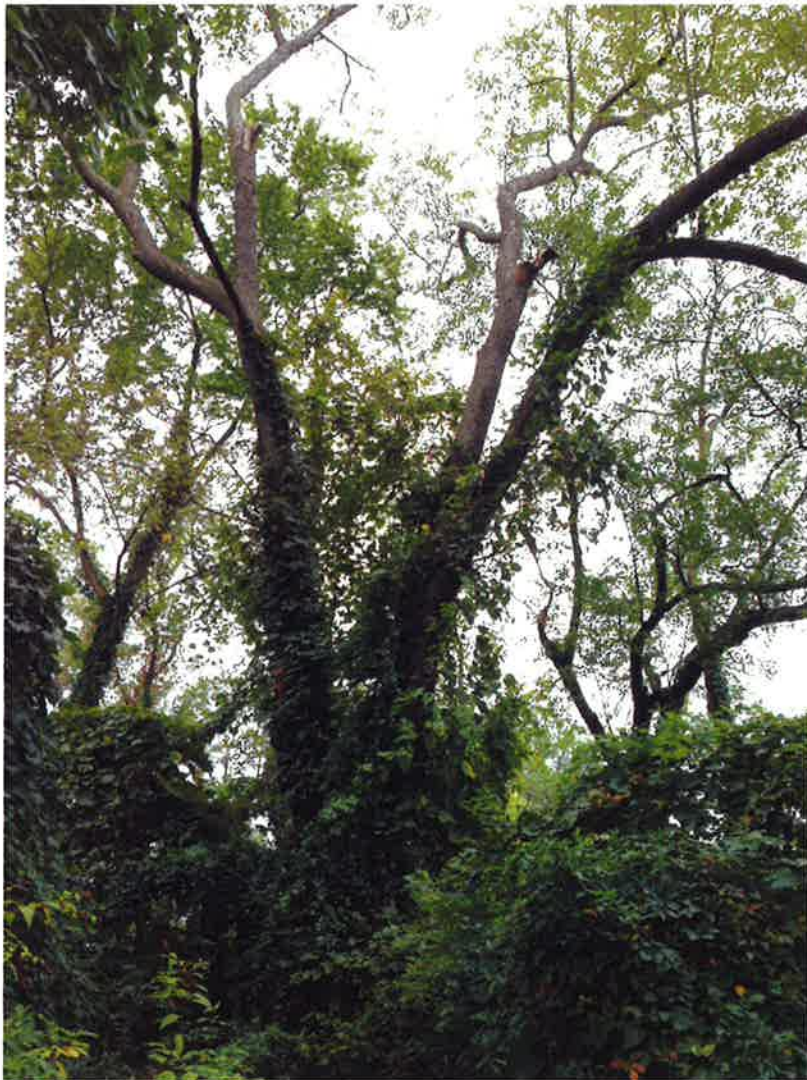
**TREE # 92**

39" Black Cherry

POOR (47%)

Co-dominant leaders and weak structure, large dead and broken limbs and crown decline

This tree is in serious decline, and is a safety hazard.
